**Flood Control Project Maintenance
Levee Inspections**

Maintenance Issue Types Only, Levee Inspection Report By Mile - Spring 2017

Reclamation District No. 2101 Blewett

Waterway	Bank	Unit Miles	Inspection Start/End	Inspector
Unit No. 01 San Joaquin River	Left	3.16	03/28/2017 03/28/2017	Maksim Khashchuk

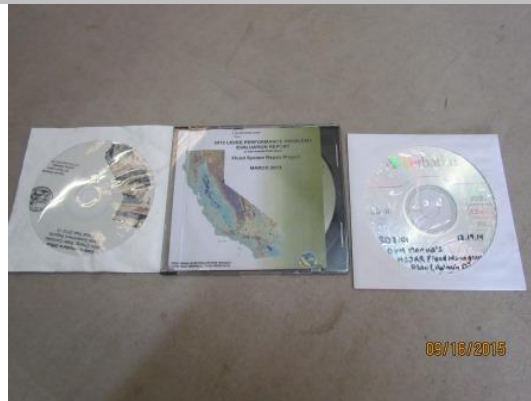
Photo 1 of 1 : SP_2017_RD2101_326_2_20170313_00004.jpg

LM Start		Rating **	A	Issue No.	2	
LM End		Issue Type +	Ma	Location *	N/A	
Category	Earthen Levee			GPS Latitude/Longitude		
				Start		End
Item	Operations & Maintenance Manuals				o	
					o	
DWR ID	DWR_RD2101_01_s_2013_2					
Comment Code						
Inspector Comment						
The LMA has the O&M Manual available electronically.

View of the O&M manual and other documentation.

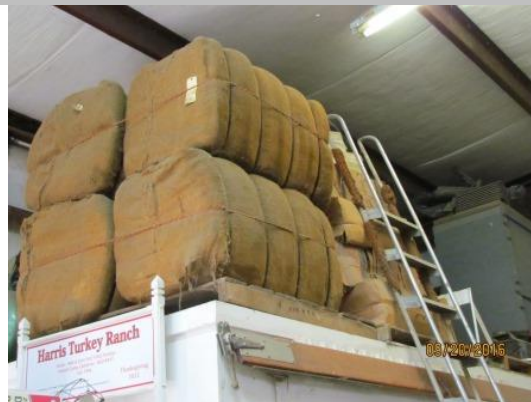
Photo 1 of 2 : SP_2017_RD2101_326_4_20170313_00005.jpg

LM Start		Rating **	A	Issue No.	4		
LM End		Issue Type +	Ma	Location *	N/A		
Category	Earthen Levee			GPS Latitude/Longitude			
				Start		End	
Item	Emergency Supplies & Equipment				o		o
					o		o
DWR ID	DWR_RD2101_01_s_2013_4						
Comment Code							
Inspector Comment							
LMA has emergency supplies on site at the warehouse.

View of the emergency flood fight supplies in the shop.

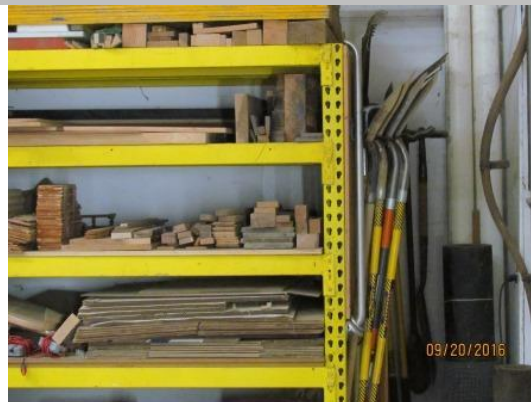
Photo 2 of 2 : SP_2017_RD2101_326_4_20170313_00006.jpg

Another view of the emergency flood fight supplies in the shop.

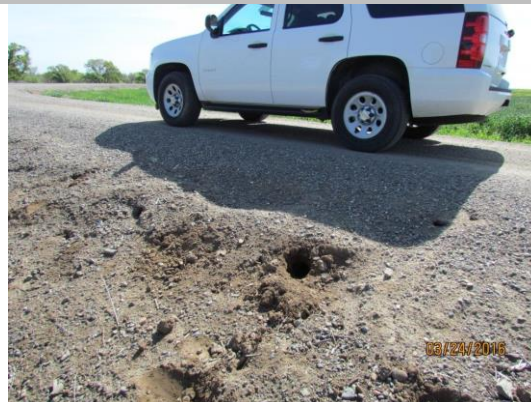
Photo 1 of 1 : SP_2017_RD2101_326_12_20170313_00008.jpg

LM Start	0.04	Rating **	M	Issue No.	12
LM End	0.04	Issue Type +	Ma	Location *	WS
Category	Earthen Levee			GPS Latitude/Longitude	
				Start	End
Item	Animal Control			37.657648 °	37.657648 °
				-121.253812 °	-121.253812 °
DWR ID	DWR_RD2101_01_s_2012_12				
Comment Code					
A3 : No rodents visible, but rodent burrows visible; need to backfill and compact or grout burrows.					
Inspector Comment					
LMA is actively exterminating rodents in this area.

View of the rodent holes on the waterside levee slope, facing upstream.

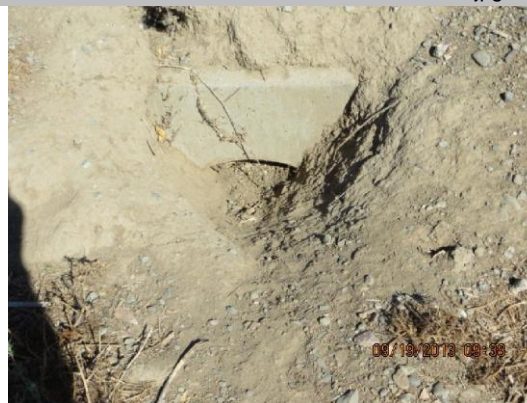
Photo 3 of 3 : UCIP_SP_2017_51391_47960.jpg

Comment Code					
Inspector Comment					
FS_ID:51391 DS_ID:20699 EP_NO: N/A Repair Type: Urgent Crossing Status: Found UCIP Comments: 11/16/2016 Same as previous inspection slide gate still missing. Also dense vegetation prevents access to crossing. Recommend removing vegetation along pipe alignment and both concrete headwalls to conduct proper inspection of structure. (O. Magana - DWR UCIP)09/17/2013 Slide gate missing from WS toe. Pipe has heavy sediment buildup. (W. Wylie - DWR UCIP) FIELD_STRUCT_DESC: 18-inch corrugated metal drainage pipe through levee, 3 feet below crown. Concrete headwalls are located on both the waterside (WS) and landside (LS) ends. Slide gate at headwall is located on the WS end. [Additional Reference(s): DWR Levee Log, 1992. USACE San Joaquin River O&M Manual Unit No. 12, December 1968, (HLM 0.05), Drawing No. 07-04-1666, sheets 1666/18 and 1666/52, station 00+70.] FS Date: 11/16/2016

Pipe and headwall visible on LS toe.

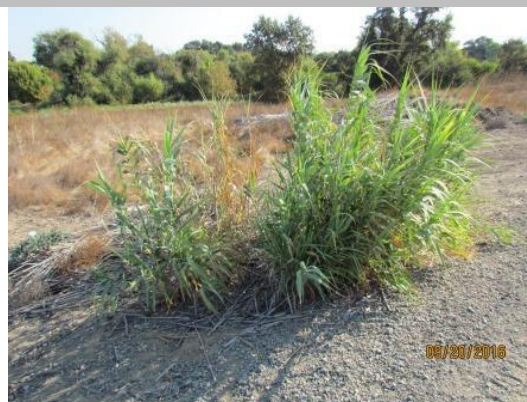
Photo 1 of 1 : SP_2017_RD2101_326_18_20170313_00010.jpg

LM Start	0.07	Rating **	M	Issue No.	18
LM End	0.07	Issue Type +	Ma	Location *	WS
Category	Earthen Levee			GPS Latitude/Longitude	
				Start	End
Item	Vegetation			37.657831 °	37.657831 °
				-121.253361 °	-121.253361 °
DWR ID	DWR_RD2101_01_f_2016_18				
Comment Code					
V2 : Remove the wild growth other than native grasses from the levee slopes.					
Inspector Comment					
Arundo on WS slope.

View of the arundo on the waterside levee slope.

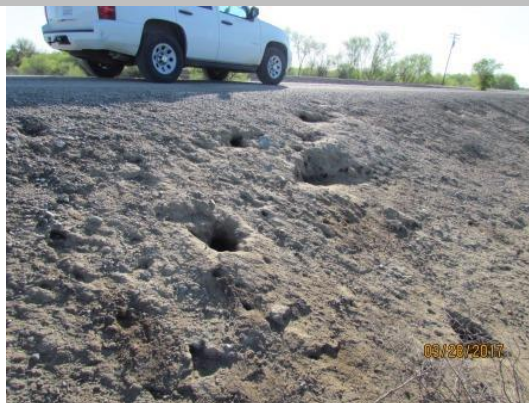
Photo 1 of 1 : SP_2017_RD2101_326_15_20170405_00041.jpg

LM Start	0.12	Rating **	U	Issue No.	15
LM End	0.12	Issue Type +	Ma	Location *	LS
Category	Earthen Levee			GPS Latitude/Longitude	
				Start	End
Item	Animal Control			37.657348 °	37.657348 °
				-121.252660 °	-121.252660 °
DWR ID	DWR_RD2101_01_s_2017_15				
Comment Code					
A1 : Exterminate rodents and backfill and compact or grout burrows.					
Inspector Comment

View of the rodent burrows on the levee slope.

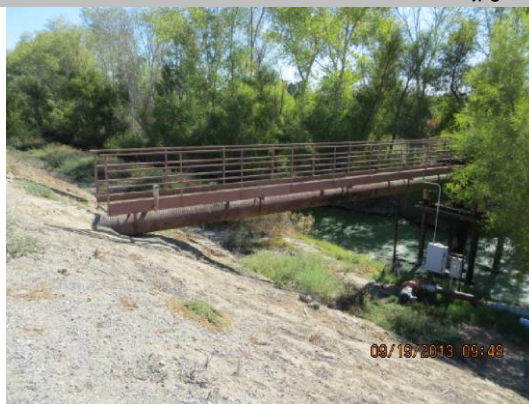
Photo 1 of 3 : UCIP_SP_2017_20752_34980.jpg

LM Start	0.20	Rating **	A/W	Issue No.	946
LM End	0.20	Issue Type +	Ma	Location *	LS
Category	Supplemental			GPS Latitude/Longitude	
				Start	End
Item	DWR UCIP LMA Responsibility			37.657130 °	37.657130 °
				-121.251695 °	-121.251695 °
DWR ID					
Comment Code					
Inspector Comment					
FS_ID:20752					
DS_ID:20700					
EP_NO: N/A					
Repair Type: No Action Needed					
Crossing Status: Found					
UCIP Comments:					
FIELD_STRUCT_DESC: 20-inch steel stormdrain pipe through levee					
2.0-feet below crown. Concrete "U" headwall and flap gate on the					
waterward end. Pump on pile structure on the landward side. Originally					
included in the 1968 O&M manual.					
FS Date: 9/19/2013

Pump on platform at LS.

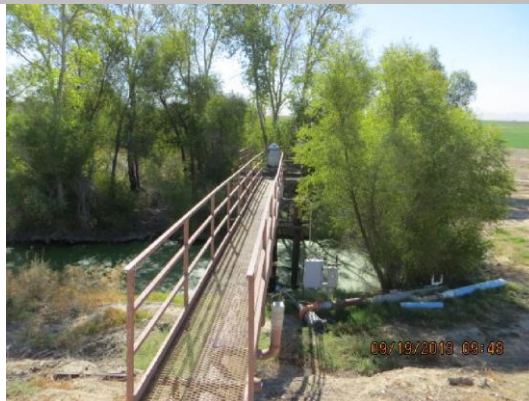
Photo 2 of 3 : UCIP_SP_2017_20752_34979.jpg

FS_ID:20752
DS_ID:20700
EP_NO: N/A
Repair Type: No Action Needed
Crossing Status: Found
UCIP Comments:
FIELD_STRUCT_DESC: 20-inch steel stormdrain pipe through levee 2.0-feet below crown. Concrete "U" headwall and flap gate on the waterward end. Pump on pile structure on the landward side. Originally included in the 1968 O&M manual.
FS Date: 9/19/2013

Pump on platform at LS.

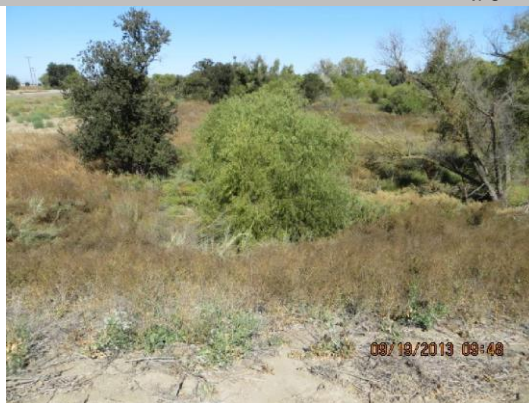
Photo 3 of 3 : UCIP_SP_2017_20752_34978.jpg

Concrete U-shaped headwall on LS toe at willow tree on WS toe.

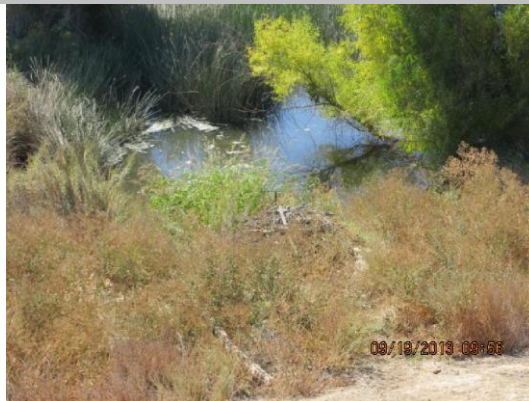
Photo 1 of 3 : UCIP_SP_2017_20785_35046.jpg

LM Start	0.31	Rating **	M	Issue No.	947
LM End	0.31	Issue Type +	Ma	Location *	LS
Category	Supplemental			GPS Latitude/Longitude	
				Start	End
Item	DWR UCIP LMA Responsibility			37.658142 °	37.658142 °
				-121.250047 °	-121.250047 °
DWR ID					
Comment Code					
Inspector Comment					
FS_ID:20785					
DS_ID:20701					
EP_NO: N/A					
Repair Type: Non-Urgent					
Crossing Status: Found					
UCIP Comments: Inlet blocked by soil from beaver activity. Outlet covered in soil.					
FIELD_STRUCT_DESC: 24-inch corrugated metal pipe through levee 21.0 feet below crown. Headwall and slide gate on the landward end. Concrete "U" headwall and flap gate on the waterward end. Originally included in the 1968 O&M manual.					
FS Date: 9/19/2013

Slide gate at concrete headwall on LS toe.

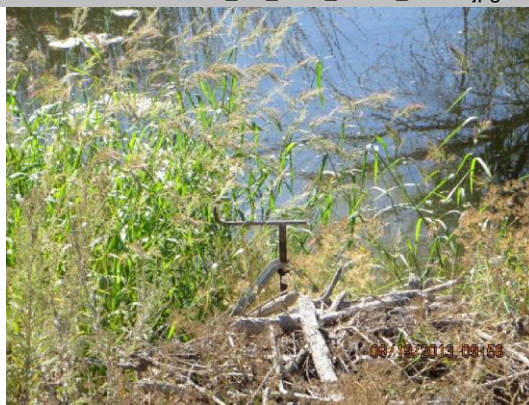
Photo 2 of 3 : UCIP_SP_2017_20785_35045.jpg

Slide gate at concrete headwall on LS toe.

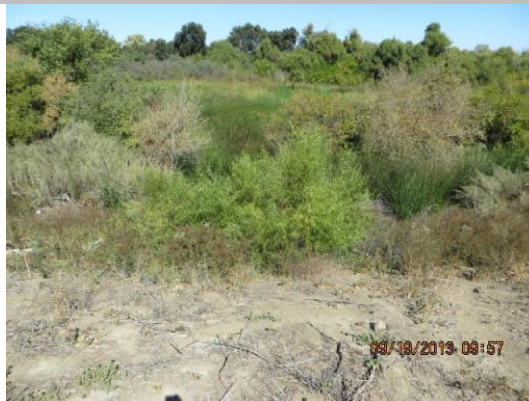
Photo 3 of 3 : UCIP_SP_2017_20785_35044.jpg

LM Start	0.31	Rating **	M	Issue No.	947 (cont)
LM End	0.31	Issue Type +	Ma	Location *	LS
Category	Supplemental			GPS Latitude/Longitude	
				Start	End
Item	DWR UCIP LMA Responsibility			37.658142 °	37.658142 °
				-121.250047 °	-121.250047 °
DWR ID					
Comment Code					
Inspector Comment					
FS_ID:20785					
DS_ID:20701					
EP_NO: N/A					
Repair Type: Non-Urgent					
Crossing Status: Found					
UCIP Comments: Inlet blocked by soil from beaver activity. Outlet covered in soil.					
FIELD_STRUCT_DESC: 24-inch corrugated metal pipe through levee 21.0 feet below crown. Headwall and slide gate on the landward end. Concrete "U" headwall and flap gate on the waterward end. Originally included in the 1968 O&M manual.					
FS Date: 9/19/2013

Outlet covered in soil but likely at willow tree on WS slope.

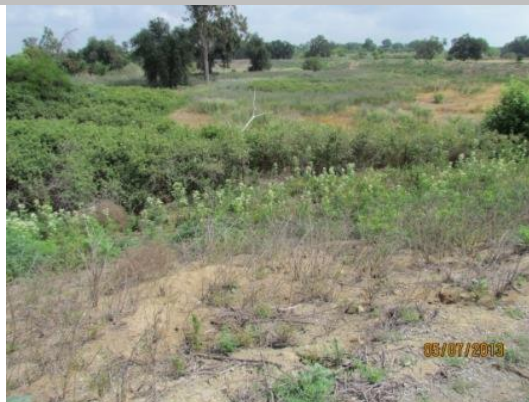
Photo 1 of 1 : SP_2017_RD2101_326_26_20170313_00012.jpg

LM Start	0.70	Rating **	A/W	Issue No.	26
LM End	0.70	Issue Type +	Ma	Location *	WS
Category	Earthen Levee			GPS Latitude/Longitude	
				Start	End
Item	Animal Control			37.659907 °	37.659907 °
				-121.244219 °	-121.244219 °
DWR ID	DWR_RD2101_01_s_2013_26				
Comment Code					
A1 : Exterminate rodents and backfill and compact or grout burrows.					
Inspector Comment

View of the rodent burrows on the waterside levee slope.

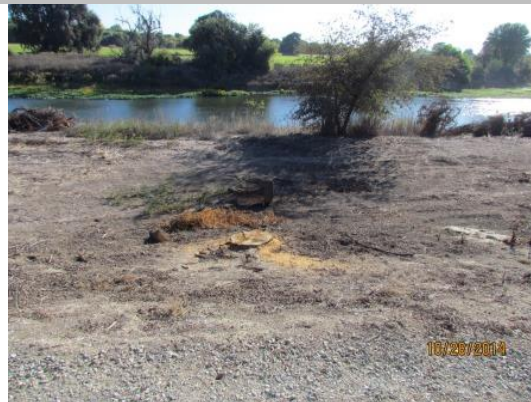
Photo 1 of 1 : SP_2017_RD2101_326_33_20170313_00017.jpg

LM Start	1.02	Rating **	N	Issue No.	33
LM End	1.02	Issue Type +	Ma	Location *	WS
Category	Earthen Levee			GPS Latitude/Longitude	
				Start	End
Item	Trim / Thin Trees			37.656745 °	37.656745 °
				-121.241104 °	-121.241104 °
DWR ID	DWR_RD2101_01_f_2014_33				
Comment Code					
T5 : Tree stumps.					
Inspector Comment

View of the tree stump at the waterside levee toe.

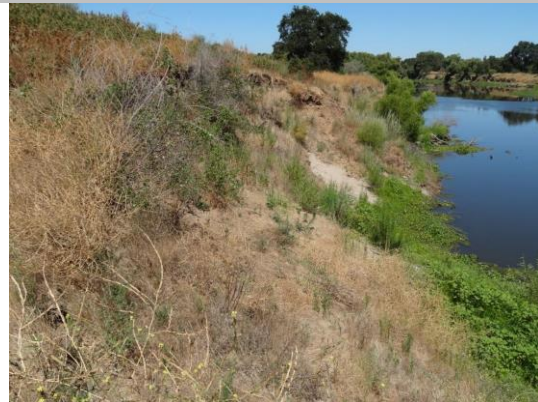
Photo 1 of 3 : SP_2017_RD2101_326_1_20170313_00001.jpg

Comment Code					
Inspector Comment					
07/12/2016: No significant change observed.					
08/19/2015: No significant change observed.					
07/17/2014: No significant change observed.					
09/20/2013: Site has been visited. There are signs of further erosion development along the levee slope and toe.					
07/18/2012: The erosion has further developed toward levee crown.					
Vegetation has been removed.					
08/18/2011: The erosion progressed significantly during the past flood season. The levee toe along the erosion site was washed away, and the erosion has cut the levee structure up to the point about 1/3 of the levee slope. The scarp height is approximately 17 feet. Very dense vegetation and trees are visible.					
10/19/2010: No significant change observed on site. Remaining levee berm topsoil is of silty sand mixture. The erosion is near the downstream transition. An eddy has formed, and has scoured away a 100-foot section of the bank, possibly encroaching into the levee prism. Vegetation on site includes willows, oak, and cotton wood located from the bench to the toe. On the landside are rows of corn crop.

08/05/2010: Recommended for Repair, per CLRO.					
2009: Site recommended as annual assessment and monitoring if critical erosion site, per CLRO CES Evaluation 2008 Report; an eddy has formed, eroding bank and intruding into the levee prism; Site # is the same as RM76.3, LM1.89; previously rated "U".					
08/30/2007: Recommended for short list of immediate repair sites; silty sand levee material. [2016 Site ID:RD2101U01RM73.92]

Upstream view of the erosion.

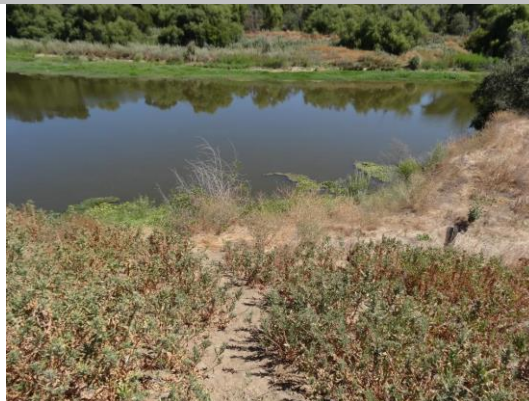
Photo 2 of 3 : SP_2017_RD2101_326_1_20170313_00002.jpg

07/12/2016: No significant change observed.
 08/19/2015: No significant change observed.
 07/17/2014: No significant change observed.
 09/20/2013: Site has been visited. There are signs of further erosion development along the levee slope and toe.
 07/18/2012: The erosion has further developed toward levee crown. Vegetation has been removed.
 08/18/2011: The erosion progressed significantly during the past flood season. The levee toe along the erosion site was washed away, and the erosion has cut the levee structure up to the point about 1/3 of the levee slope. The scarp height is approximately 17 feet. Very dense vegetation and trees are visible.
 10/19/2010: No significant change observed on site. Remaining levee berm topsoil is of silty sand mixture. The erosion is near the downstream transition. An eddy has formed, and has scoured away a 100-foot section of the bank, possibly encroaching into the levee prism. Vegetation on site includes willows, oak, and cotton wood located from the bench to the toe. On the landside are rows of corn crop.

08/05/2010: Recommended for Repair, per CLRO.
 2009: Site recommended as annual assessment and monitoring if critical erosion site, per CLRO CES Evaluation 2008 Report; an eddy has formed, eroding bank and intruding into the levee prism; Site # is the same as RM76.3, LM1.89; previously rated "U".
 08/30/2007: Recommended for short list of immediate repair sites; silty sand levee material. [2016 Site ID:RD2101U01RM73.92]

Looking at the erosion from the levee top.

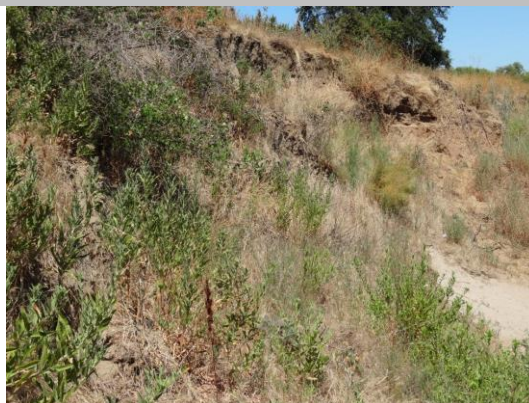
Photo 3 of 3 : SP_2017_RD2101_326_1_20170313_00003.jpg

Close view of the erosion. Levee crest is approximately 8 feet above the erosion.

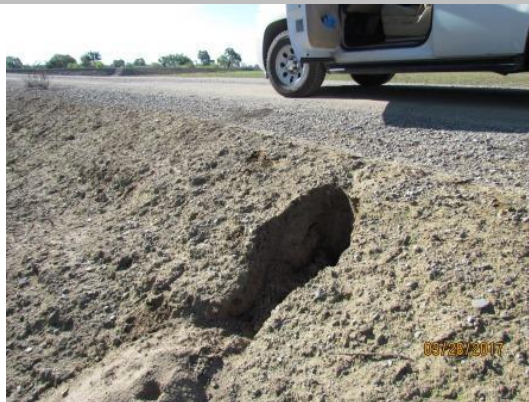
Photo 1 of 1 : SP_2017_RD2101_326_24_20170405_00043.jpg

View of the rodent burrow on the levee slope.

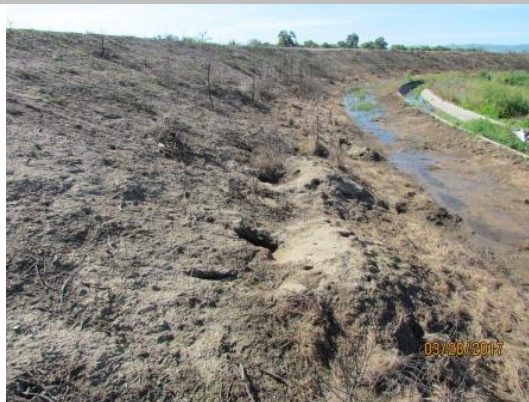
Photo 1 of 1 : SP_2017_RD2101_326_25_20170405_00044.jpg

LM Start	2.46	Rating **	U	Issue No.	25
LM End	2.46	Issue Type +	Ma	Location *	LS
Category	Earthen Levee			GPS Latitude/Longitude	
				Start	End
Item	Animal Control			37.644691 °	37.644691 °
				-121.227681 °	-121.227681 °
DWR ID	DWR_RD2101_01_s_2017_25				
Comment Code					
A1 : Exterminate rodents and backfill and compact or grout burrows.					
Inspector Comment

View of the multiple rodent burrows on the levee slope.

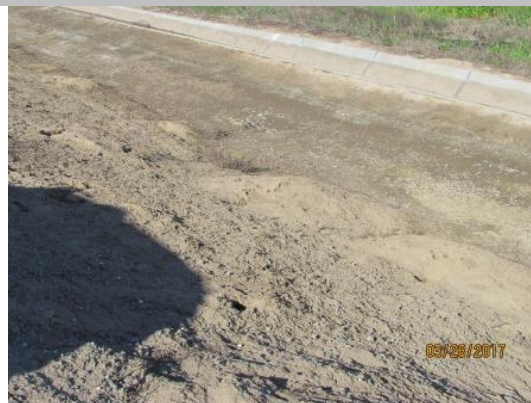
Photo 1 of 1 : SP_2017_RD2101_326_30_20170405_00047.jpg

View of the rodent burrows on the levee slope near the toe.

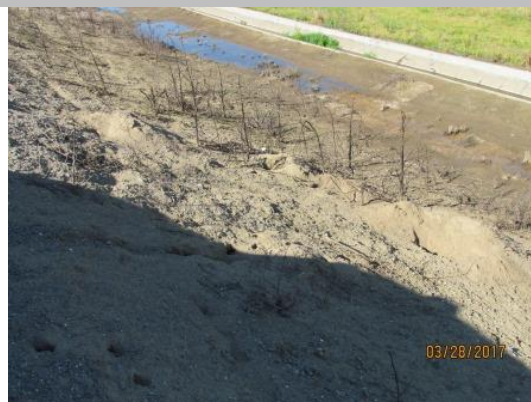
Photo 1 of 1 : SP_2017_RD2101_326_36_20170405_00045.jpg

LM Start	2.56	Rating **	U	Issue No.	36
LM End	2.56	Issue Type +	Ma	Location *	LS
Category	Earthen Levee			GPS Latitude/Longitude	
				Start	End
Item	Animal Control			37.643733 °	37.643733 °
				-121.229083 °	-121.229083 °
DWR ID	DWR_RD2101_01_s_2017_36				
Comment Code					
A1 : Exterminate rodents and backfill and compact or grout burrows.					
Inspector Comment

View of the multiple rodent burrows on the levee slope.

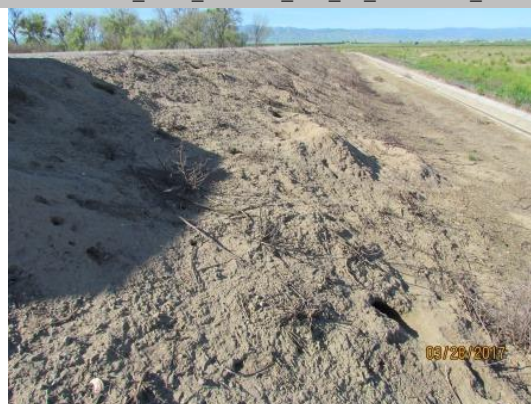
Photo 1 of 1 : SP_2017_RD2101_326_37_20170405_00046.jpg

LM Start	2.67	Rating **	U	Issue No.	37
LM End	2.67	Issue Type +	Ma	Location *	LS
Category	Earthen Levee			GPS Latitude/Longitude	
				Start	End
Item	Animal Control			37.642436 °	37.642436 °
				-121.229854 °	-121.229854 °
DWR ID	DWR_RD2101_01_s_2017_37				
Comment Code					
A1 : Exterminate rodents and backfill and compact or grout burrows.					
Inspector Comment

View of the multiple rodent burrows on the levee slope.

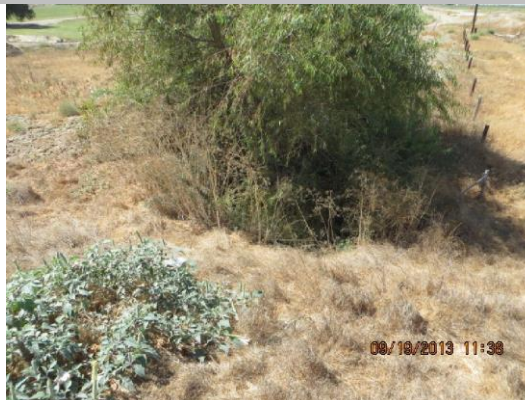
Photo 1 of 3 : UCIP_SP_2017_51392_35142.jpg

FS_ID:51392
DS_ID:20705
EP_NO: N/A
Repair Type: Urgent
Crossing Status: Found
UCIP Comments: 11/16/2016 No access available. Need to coordinate with LMA to obtain access for proper inspection at a later date. (O. Magana - DWR UCIP)09/19/2013 Flap gate missing from WS headwall. (W. Wylie - DWR UCIP)
FIELD_STRUCT_DESC: 24-inch corrugated metal drain pipe through levee, 11 feet below crown. Concrete "U" headwall on both waterside (WS) and landside (LS) ends. Flap gate is located on the WS end.
[Additional Reference(s): DWR Levee Log, 1992. USACE San Joaquin River O&M Manual Unit No. 12, December 1968, (HLM 2.85), Drawing No. 07-04-1666, sheets 1666/13 and 1666/51, station 421+30]
FS Date: 11/16/2016

Concrete headwall visible at LS toe in ditch.

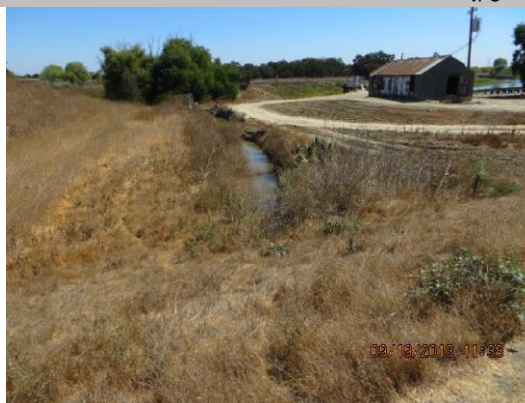
Photo 2 of 3 : UCIP_SP_2017_51392_35141.jpg

Concrete headwall visible on WS toe at canal.

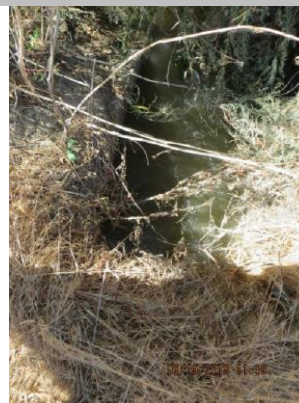
Photo 3 of 3 : UCIP_SP_2017_51392_35140.jpg

Comment Code					
Inspector Comment					
FS_ID:51392 DS_ID:20705 EP_NO: N/A Repair Type: Urgent Crossing Status: Found UCIP Comments: 11/16/2016 No access available. Need to coordinate with LMA to obtain access for proper inspection at a later date. (O. Magana - DWR UCIP)09/19/2013 Flap gate missing from WS headwall. (W. Wylie - DWR UCIP) FIELD_STRUCT_DESC: 24-inch corrugated metal drain pipe through levee, 11 feet below crown. Concrete "U" headwall on both waterside (WS) and landside (LS) ends. Flap gate is located on the WS end. [Additional Reference(s): DWR Levee Log, 1992. USACE San Joaquin River O&M Manual Unit No. 12, December 1968, (HLM 2.85), Drawing No. 07-04-1666, sheets 1666/13 and 1666/51, station 421+30] FS Date: 11/16/2016

Concrete headwall at LS toe.

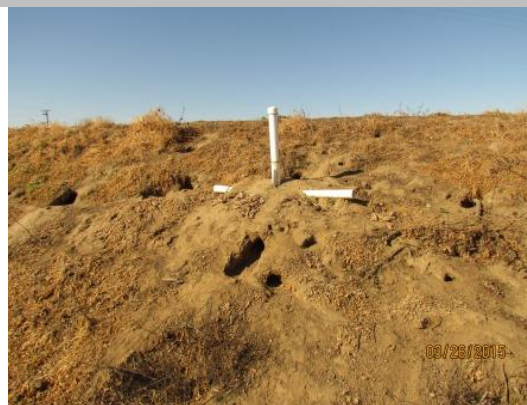
Photo 1 of 1 : SP_2017_RD2101_326_27_20170313_00013.jpg

LM Start	2.83	Rating **	U	Issue No.	27
LM End	2.83	Issue Type +	Ma	Location *	WS
Category	Earthen Levee			GPS Latitude/Longitude	
				Start	End
Item	Animal Control			37.640425 °	37.640425 °
				-121.230139 °	-121.230139 °
DWR ID	DWR_RD2101_01_s_2012_27				
Comment Code					
A3 : No rodents visible, but rodent burrows visible; need to backfill and compact or grout burrows.					
Inspector Comment					
Burrows on both sides of levee. Backfill the burrows to restore the levee to original condition.

View of multiple rodent holes on the levee slope.

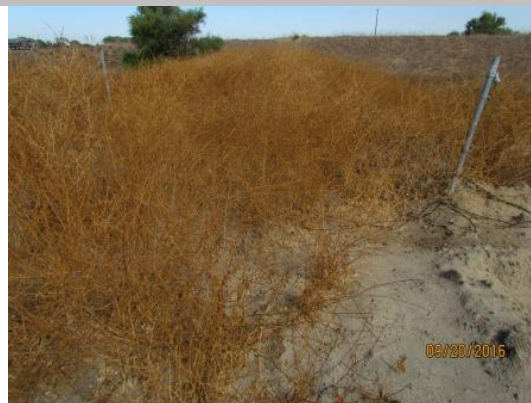
Photo 1 of 1 : SP_2017_RD2101_326_34_20170313_00018.jpg

View of the vegetation on levee crown.

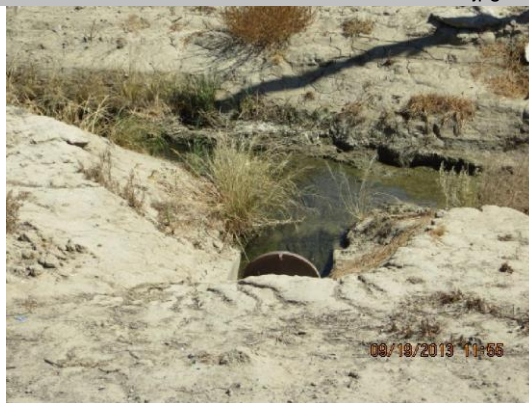
Photo 1 of 3 : UCIP_SP_2017_20875_35156.jpg

LM Start	2.87	Rating **	A/W	Issue No.	953
LM End	2.87	Issue Type +	Ma	Location *	LS
Category	Supplemental			GPS Latitude/Longitude	
				Start	End
Item	DWR UCIP LMA Responsibility			37.639924 °	37.639924 °
				-121.230005 °	-121.230005 °
DWR ID					
Comment Code					
Inspector Comment					
FS_ID:20875 DS_ID:20707 EP_NO: N/A Repair Type: No Action Needed Crossing Status: Found UCIP Comments: FIELD_STRUCT_DESC: 1 of 2: 24-inch CMP stormdrain pipe through levee 12.5 feet below crown. Concrete "U" headwall on each end. Flap gate on waterward end. Originally included in the 1968 O&M manual. FS Date: 9/19/2013

Flapgate on WS toe at concrete headwall.

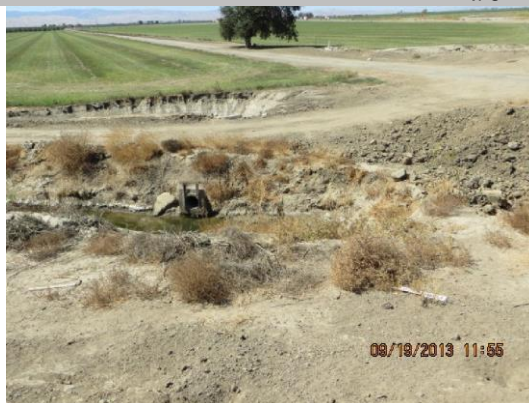
Photo 2 of 3 : UCIP_SP_2017_20875_35155.jpg

Inlet on LS toe with concrete headwall.

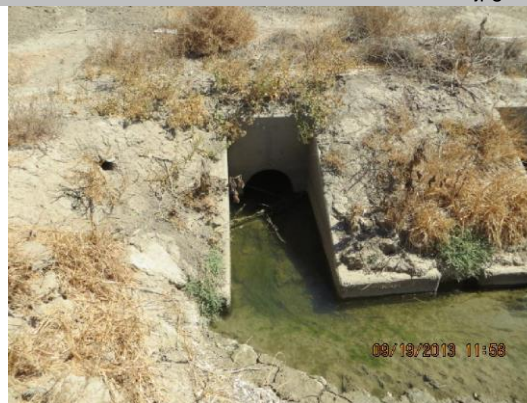
Photo 3 of 3 : UCIP_SP_2017_20875_35154.jpg

LM Start	2.87	Rating **	A/W	Issue No.	953 (cont)	
LM End	2.87	Issue Type +	Ma	Location *	LS	
Category	Supplemental			GPS Latitude/Longitude		
				Start	End	
Item	DWR UCIP LMA Responsibility			37.639924 °	37.639924 °	
				-121.230005 °	-121.230005 °	
DWR ID						
Comment Code						
Inspector Comment						
FS_ID:20875						
DS_ID:20707						
EP_NO: N/A						
Repair Type: No Action Needed						
Crossing Status: Found						
UCIP Comments:						
FIELD_STRUCT_DESC: 1 of 2: 24-inch CMP stormdrain pipe through						
levee 12.5 feet below crown. Concrete "U" headwall on each end. Flap						
gate on waterward end. Originally included in the 1968 O&M manual.						
FS Date: 9/19/2013

Inlet on LS toe with concrete headwall.

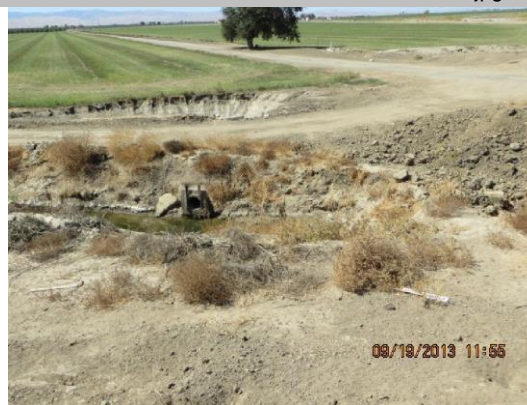
Photo 1 of 3 : UCIP_SP_2017_20876_35159.jpg

LM Start	2.87	Rating **	A/W	Issue No.	954
LM End	2.87	Issue Type +	Ma	Location *	LS
Category	Supplemental			GPS Latitude/Longitude	
				Start	End
Item	DWR UCIP LMA Responsibility			37.639884 °	37.639884 °
				-121.230008 °	-121.230008 °
DWR ID					
Comment Code					
Inspector Comment					
FS_ID:20876					
DS_ID:20709					
EP_NO: N/A					
Repair Type: No Action Needed					
Crossing Status: Found					
UCIP Comments:					
FIELD_STRUCT_DESC: 2 of 2: 24-inch pipe through levee 12.5 feet below crown. Concrete "U" headwall on each end. Flap gate on waterward end. Originally included in the 1968 O&M manual.					
FS Date: 9/19/2013

Concrete inlet on LS toe at canal.

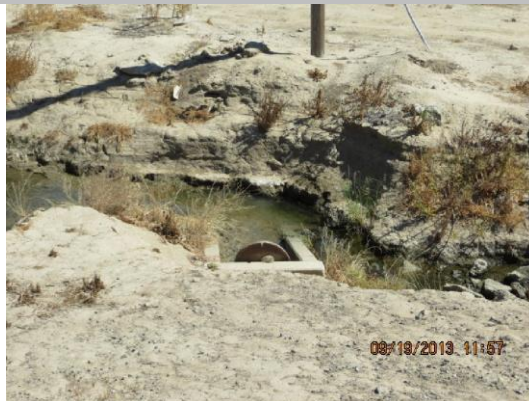
Photo 2 of 3 : UCIP_SP_2017_20876_35158.jpg

FS_ID:20876
DS_ID:20709
EP_NO: N/A
Repair Type: No Action Needed
Crossing Status: Found
UCIP Comments:
FIELD_STRUCT_DESC: 2 of 2: 24-inch pipe through levee 12.5 feet below crown. Concrete "U" headwall on each end. Flap gate on waterward end. Originally included in the 1968 O&M manual.
FS Date: 9/19/2013

Concrete U-shaped headwall on WS toe with flapgate.

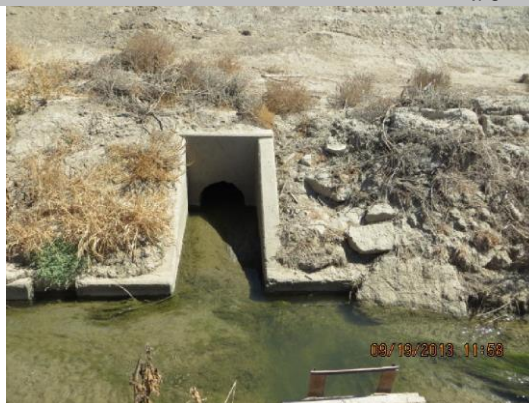
Photo 3 of 3 : UCIP_SP_2017_20876_35157.jpg

Concrete inlet on LS toe at canal.

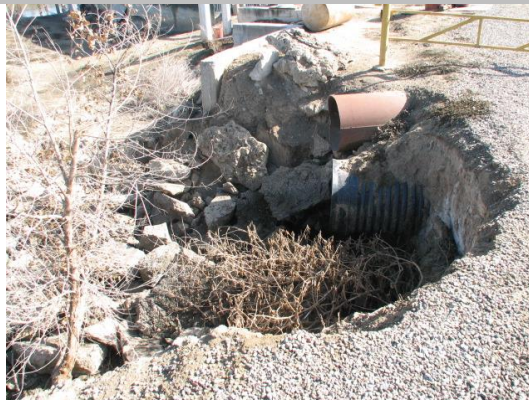
Photo 2 of 2 : SP_2017_RD2101_326_29_20170313_00016.jpg

Levee slope is being eroded at this location. Repair needed to preserve access road.

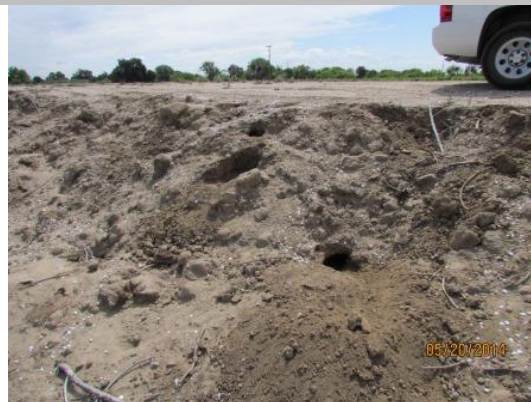
Photo 1 of 1 : SP_2017_RD2101_326_17_20170313_00009.jpg

Numerous burrows present, some already caving in, others are active.

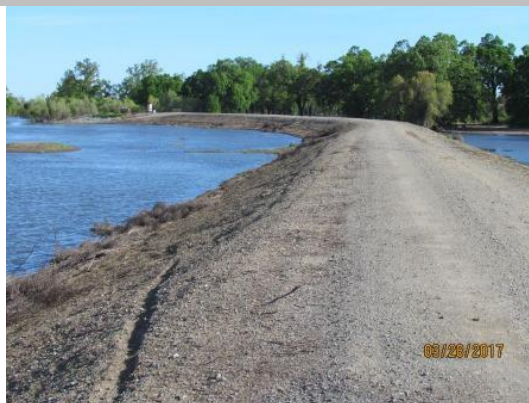
Photo 1 of 1 : SP_2017_RD2101_327_1_20170405_00001.jpg

View of the acceptable vegetation on the levee slope.
